Inspection Report

D2 Home and property Inspections LLC

**John DeWitt
3989 North 20th
Ozark Mo. 65721**

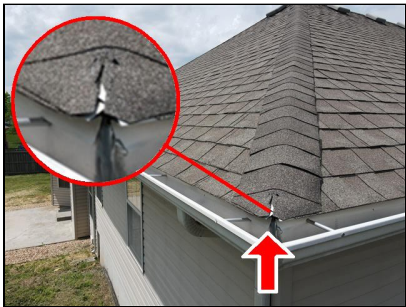
1.0 Item 1(Picture)

(1) Right rear corner, roof covering damaged. Recommend repair by a qualified contractor.

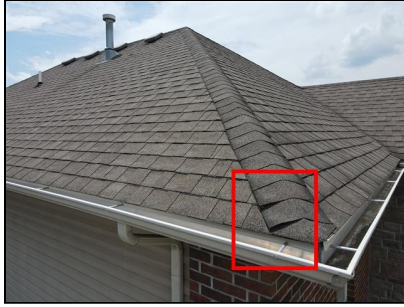
1.0 Item 2(Picture)

(2) Shingles starting to curl. Recommend to monitor.

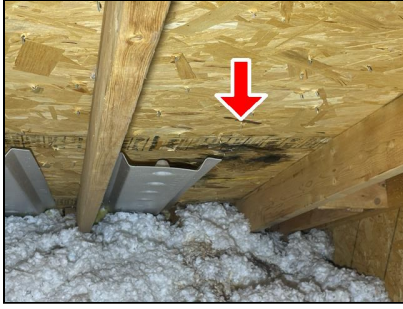
1.5 Item 1(Picture)

Moisture stains present. This is located approximately right of the front door.

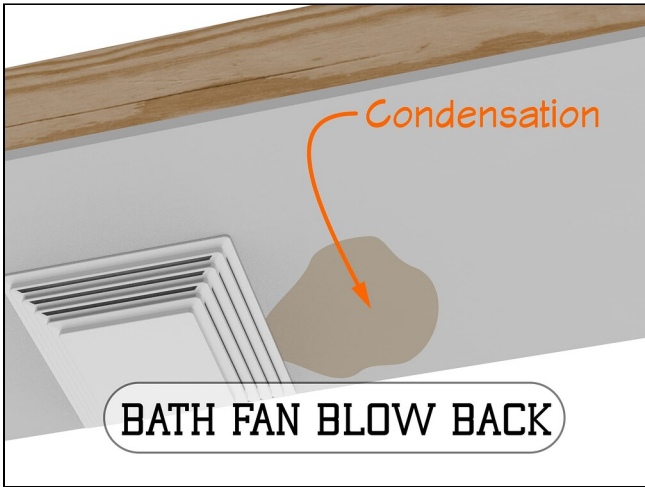
1.9 Item 5(Picture)

Exhaust fans are to be vented to the outside of the home with an vent cap. Bathroom vents are pulling moisture from showers including cool and warm air. When cool and warm air mix, this could cause moisture. Excessive moisture will cause condensation on roof members and insulation. This could cause mold and may leave your home unlivable. Recommend repair by qualified contractor.

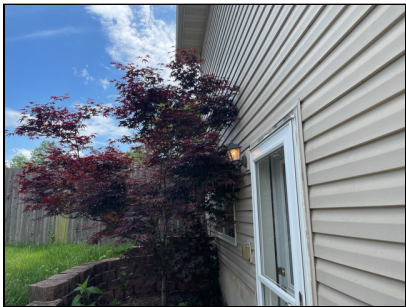
2.0 Item 1(Picture)

(1) Recommend trimming trees/shrubbery away from the home. Vegetation can grow causing damage to the siding.

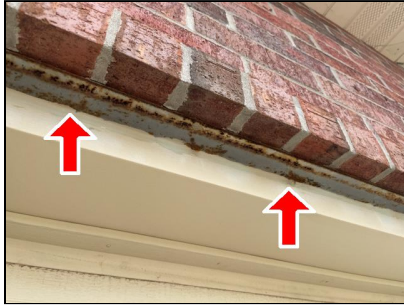
2.0 Item 2(Picture)

(2) The steel plate supporting the brick veneer over the garage doors is showing signs of rust. In the near future sanding and repainting may be necessary.

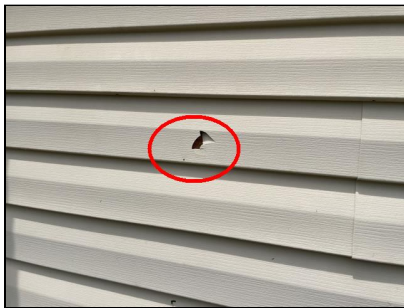
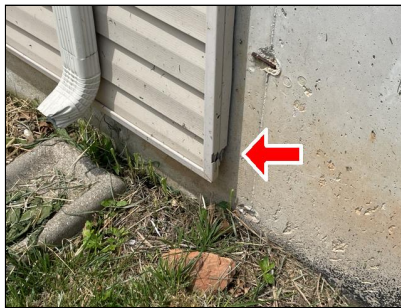
(3) In various places the siding and trim has minor damage.

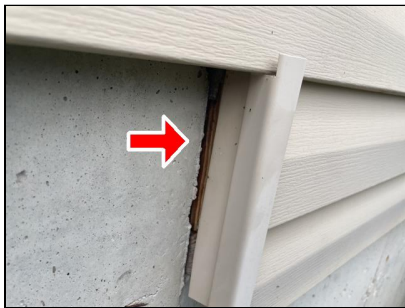
2.0 Item 6(Picture)

(5) Recommend caulking where the siding meets the foundation. Barewood is showing.

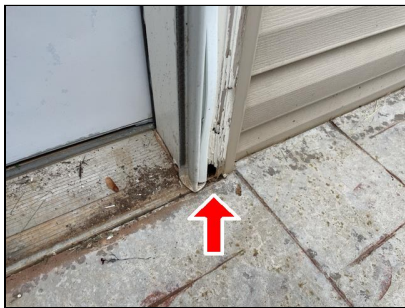
2.1 Item 1(Picture)

- 1. Front-facing left side, trim has minor damage around the door.
- 2. Recommend weatherproofing the trim. This will help prolong the life of the wood.

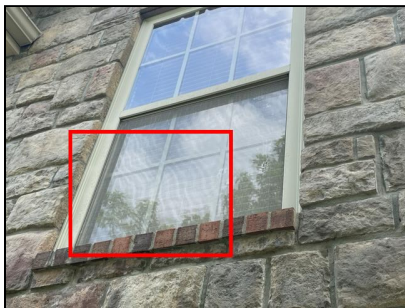
2.2 Item 1(Picture)

(1) In various places the screens has minor damage.

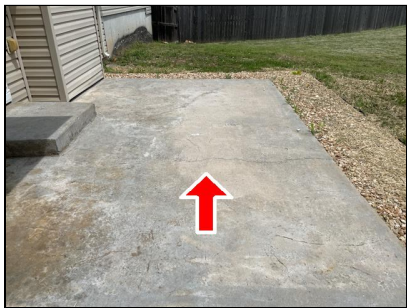
2.3 Item 1(Picture)

The back patio has vertical cracks. Recommend maintaining a positive slope so the water will drain away from the patio.

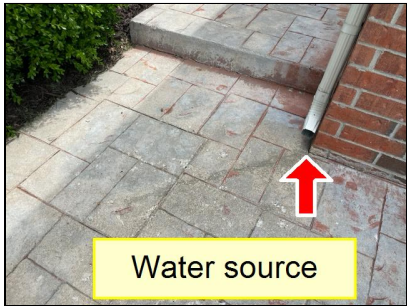
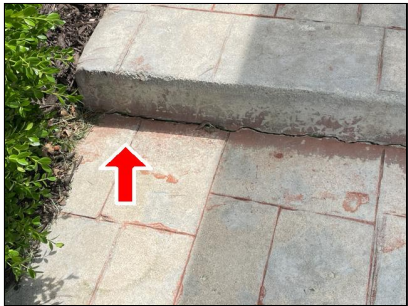
(1) Vertical crack on the sidewalk left of the drive. Sidewalk has minor settling. Recommend maintaining a positive slope so water will drain away from the walkway.

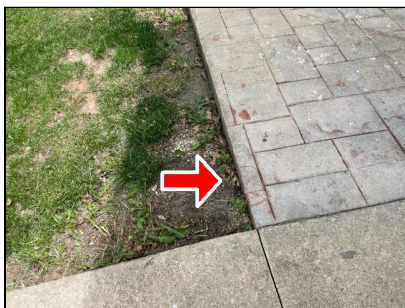
2.4 Item 3(Picture)

(2) Minor erosion around the sidewalk. Recommend adding Soil.

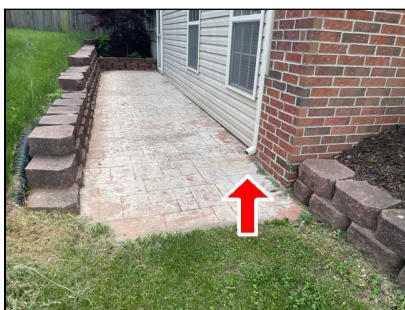
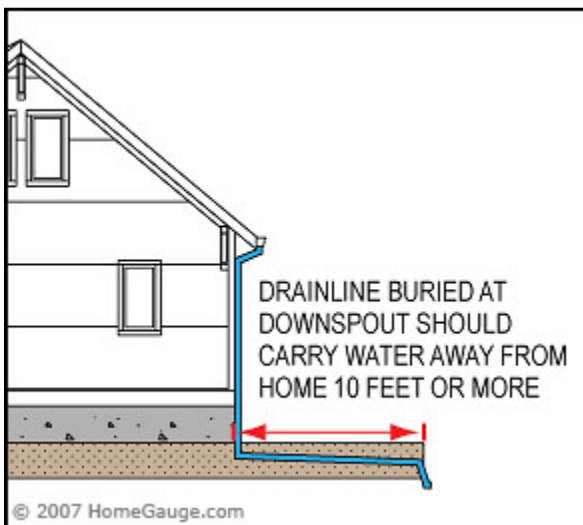
(3) The ground drain lines need extending and burying below the surface. Water should flow away from the foundation.

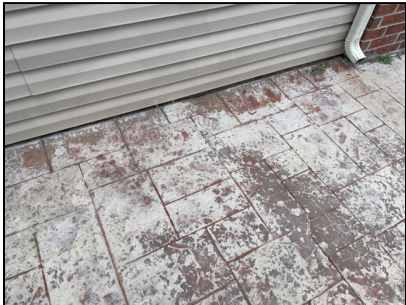
2.4 Item 7(Picture)

(4) Front-facing left side, patio has vertical cracks in various places. Recommend maintaining a positive slope so the water will drain away from the patio.

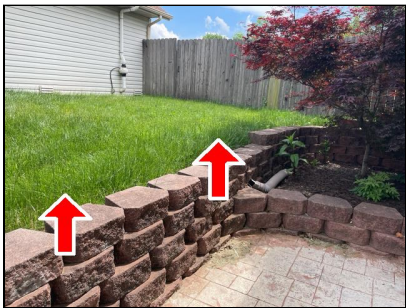
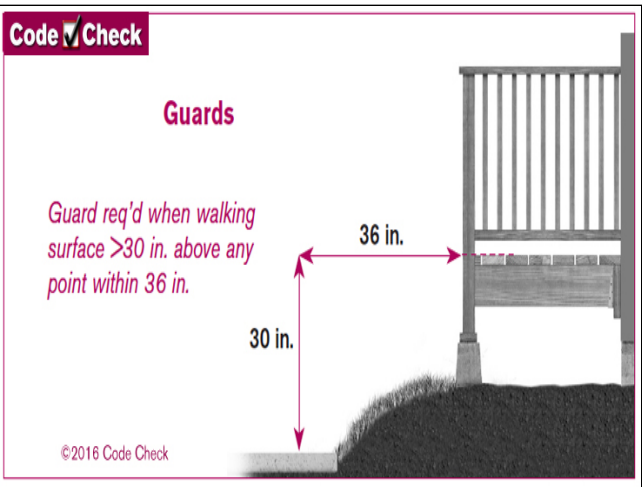
(5) Recommend adding a guard rail or landscaping to prevent a person from walking off causing injury.

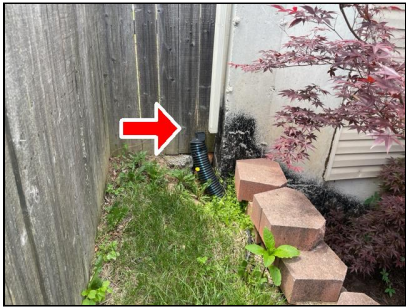
2.4 Item 10(Picture)

(6) Left rear corner of the home, recommend reattaching the downspout to the underground pipe. This will help prevent erosion.

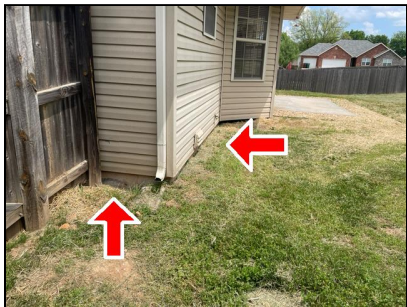
2.4 Item 11(Picture)

(7) There is a negative slope at the rear of home and can cause or contribute to water intrusion or deterioration. I recommend correcting landscape to drain water away from home.

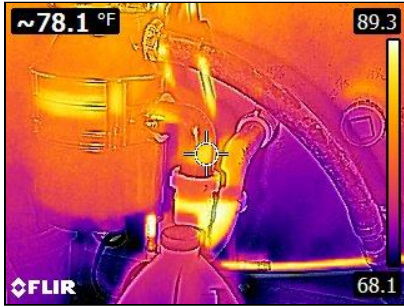
4.2 Item 1(Picture)

Infrared shows water in yellow. No leaks found during the inspection

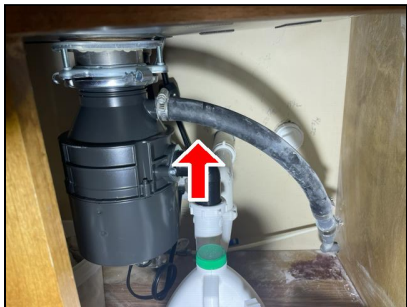
4.4 Item 2(Picture)

(2) Recommend looping dishwasher drain. If drains not looped, water from the sink could possible drain back into the dishwasher.

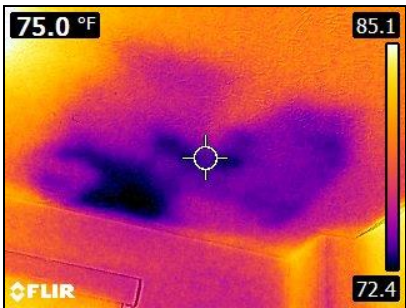
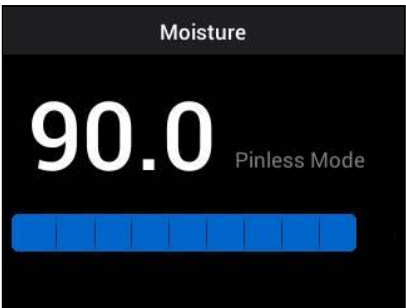
(1) Infrared shows moisture in blue. (this is located by the front door) Moisture meter shows 90% moisture present. This is considered active.

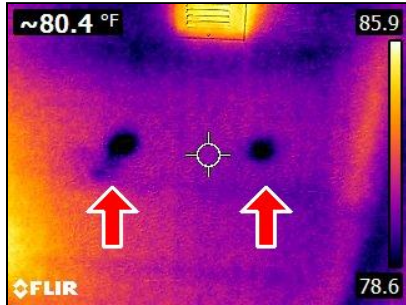
5.0 Item 4(Picture)

(2) In the primary bathroom down stairs, infrared shows in blue where moisture is present. This is located under the secondary bathroom where the drain was leaking.

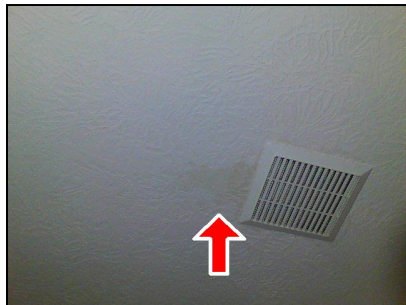
5.0 Item 6(Picture)

(3) Moisture stain present around the fan in the down stairs primary bathroom. Infrared shows no active moisture during the inspection.

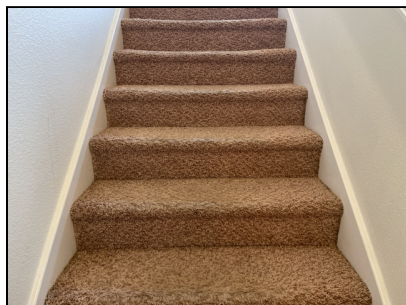
5.2 Item 1(Picture)

(1) The carpet on the stairs is showing signs of wear.

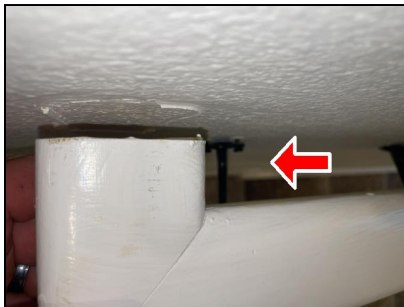
5.3 Item 1(Picture)

The handrail going up the stairs is loose.

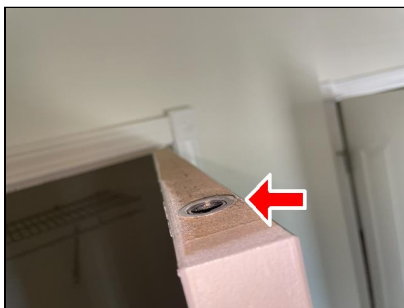
5.4 Item 1(Picture)

In the upstairs bedroom left of the primary bathroom, the balls for the closing mechanism on the closet door are missing.

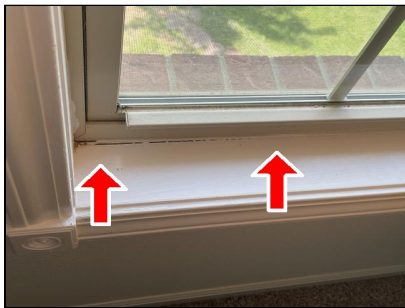
5.5 Item 1(Picture)

Recommend caulking around each window as needed.

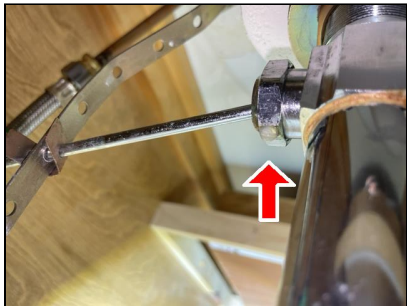
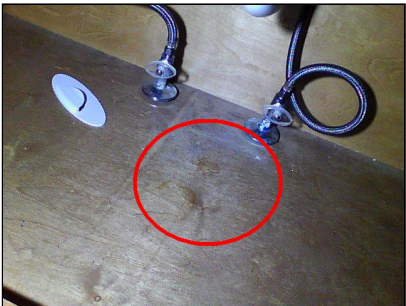
(1) The arm for the stopper mechanism is leaking where it enters the drain. Infrared shows water in yellow. Recommend repair by a qualified contractor. (The upstairs primary bathroom.)

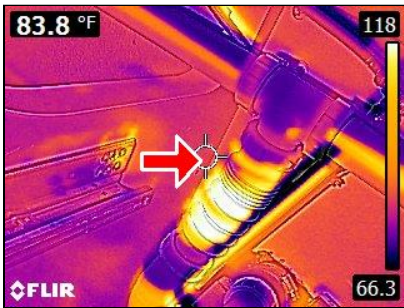
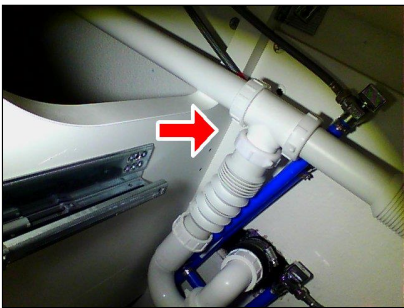
(2) The drain in the primary bathroom upstairs is leaking. Recommend repair by a qualified contractor.

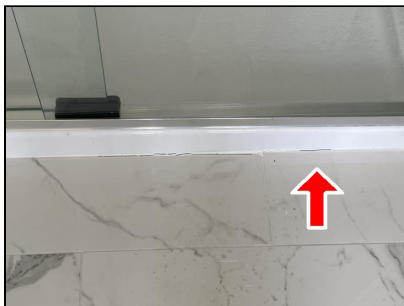
6.5 Item 1(Picture)

(1) Recommend caulking around the base of the shower in the upstairs secondary bathroom. This will help prevent water from entering the subfloor.

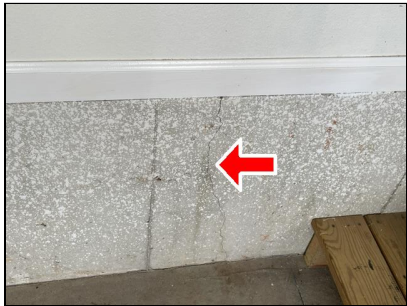
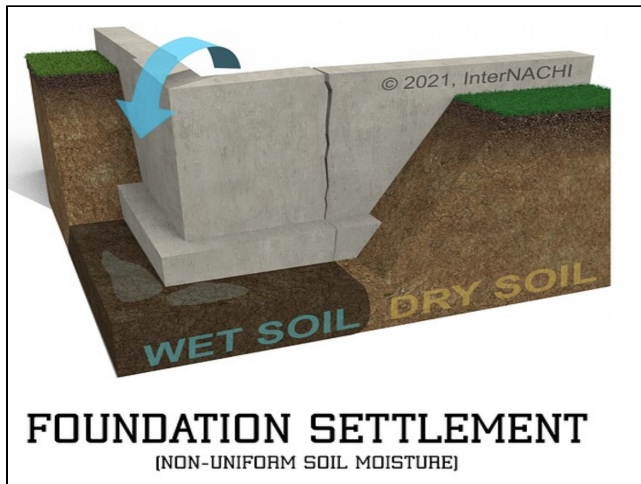
(1) A vertical crack in various places. Recommend maintaining a positive slope so water will drain away from the foundation.

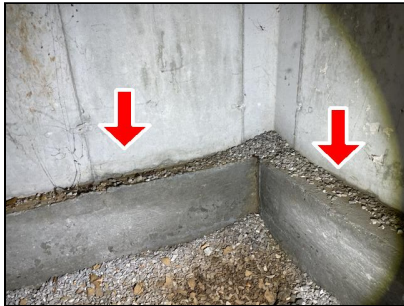
7.0 Item 4(Picture)

(2) Signs of moisture intrusion at the right rear corner of the home. Recommend maintaining a positive slope so the water will drain away from the foundation.

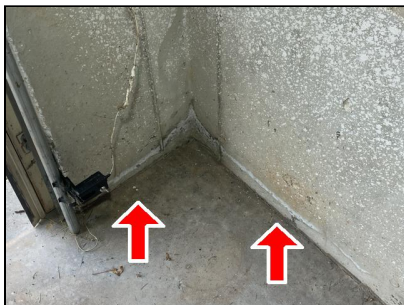
7.0 Item 5(Picture)

(3) White efflorescence (powder substance) on block wall indicates moisture is in contact with the masonry. This does not necessarily indicate that intrusion will occur. I recommend checking the gutters and the downspout drain lines for proper operation. Also, a water proofing paint could be applied to the interior side of the block if necessary. Efflorescence is found on many homes without water intrusion occurring inside the home. But, it should alert you to the possibility that future steps may be needed.(garage)

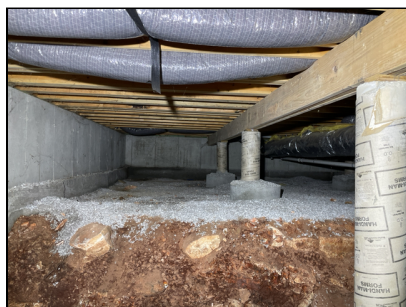
7.6 Item 1(Picture)

The vapor barrier (plastic) on the crawlspace ground is missing. A vapor barrier provides added protection to the floor system from moisture or dampness that can enter from ground. A qualified person should repair or replace as needed.

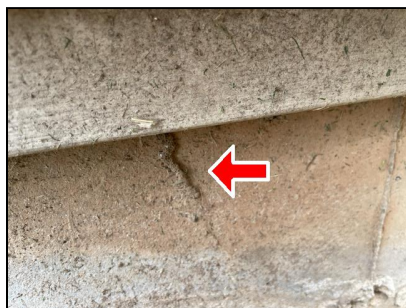
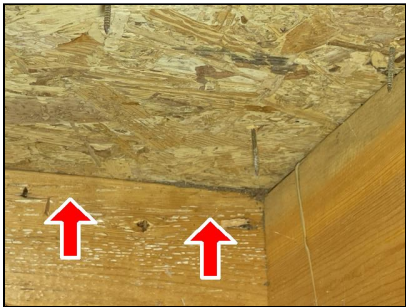
Evidence of Termites observed.

Recommend a licensed pest control operator's evaluation for the scope of treatment/costs if not currently under a warranty.

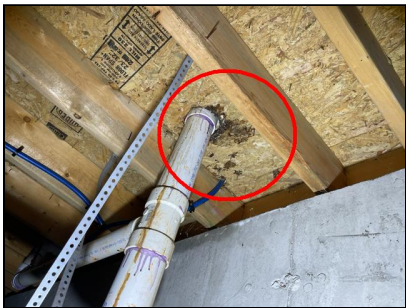
8.0 Item 1(Picture)

- (1) The flange is leaking in the primary bathroom downstairs. Recommend repair by a qualified contractor.

(1) The flange is leaking in the primary bathroom downstairs. Recommend repair by a qualified contractor.

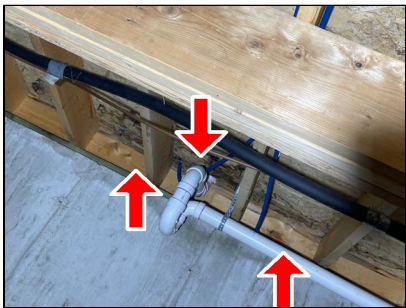
8.0 Item 2(Picture)

(2) 2 inch drain for the laundry room is leaking. Recommend repair by a qualified contractor.

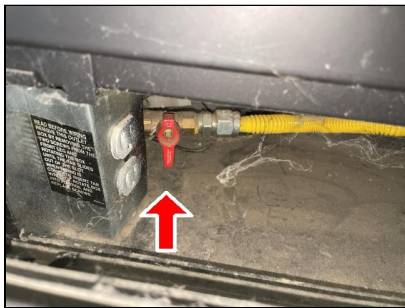
10.7 Item 1(Picture)

Recommend asking the owners to supply fuel to the fireplace to make sure it's operational.

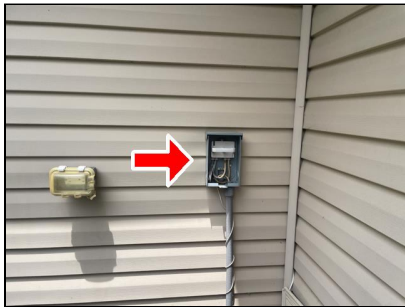
10.8 Item 3(Picture)

(2) Recommend a cover for the main disconnect on the AC unit.
