Inspection Report

D2 Home and property Inspections LLC

**John DeWitt
3989 North 20th
Ozark Mo. 65721**

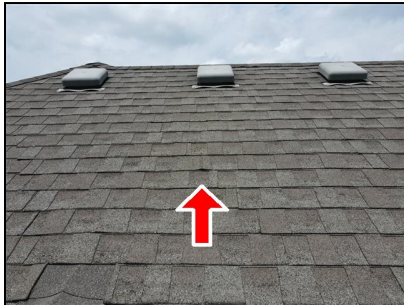
1.0 Item 3(Picture)

(3)

1. Roof has some nail popping.
2. Roof has some granule lost.

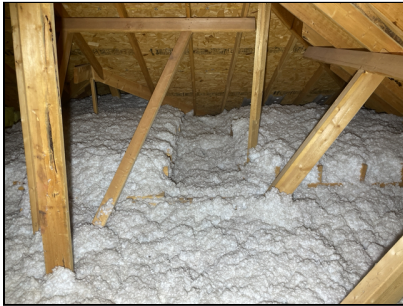
1.7 Item 1(Picture)

It is about 13 inches thick or 47.6 R-Value.

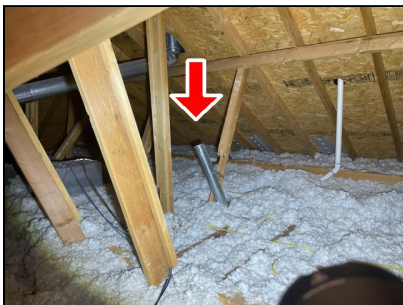
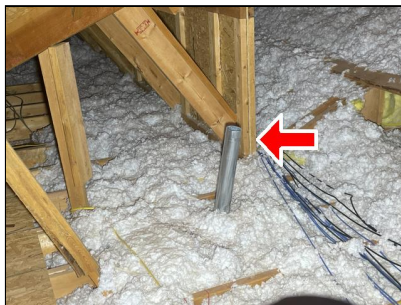
Exhaust fans are to be vented to the outside of the home with an vent cap. Bathroom vents are pulling moisture from showers including cool and warm air. When cool and warm air mix, this could cause moisture. Excessive moisture will cause condensation on roof members and insulation. This could cause mold and may leave your home unlivable. Recommend repair by qualified contractor.

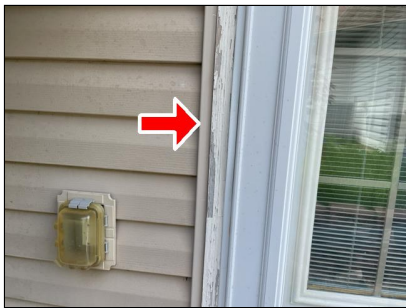
2.1 Item 2(Picture)

- 1. Front-facing left side, trim has minor damage around the door.
- 2. Recommend weatherproofing the trim. This will help prolong the life of the wood.

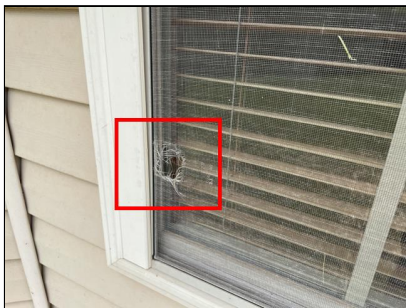
2.2 Item 2(Picture)

(1) In various places the screens has minor damage.

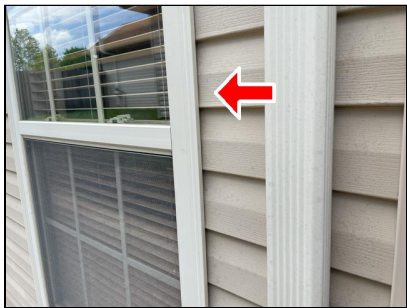
2.2 Item 3(Picture)

(2) No J trim installed around the windows.

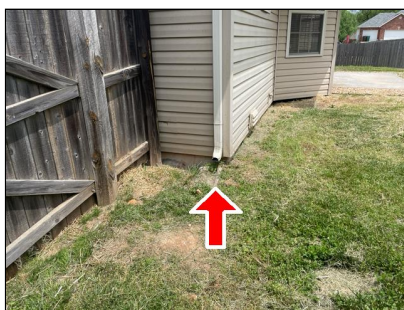
2.4 Item 5(Picture)

(3) The ground drain lines need extending and burying below the surface. Water should flow away from the foundation.

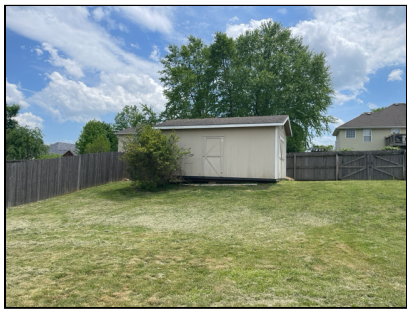
2.7 Item 1(Picture)

I did not inspect any additional buildings. I only inspected the main structure. Deficiencies may exist with these structures or building (s). Our company makes no representation to the condition of these structures or building (s).

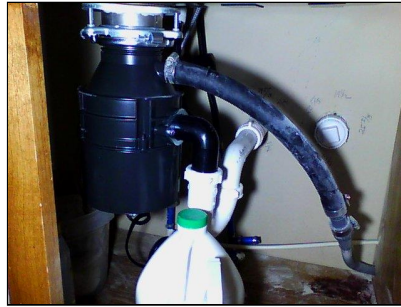
4.2 Item 2(Picture)

Infrared shows water in yellow. No leaks found during the inspection

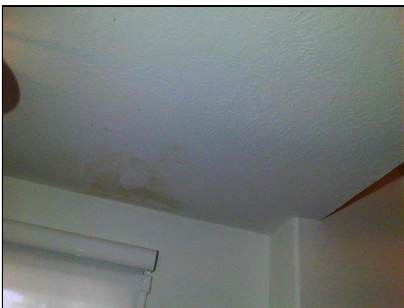
5.0 Item 2(Picture)

(1) Infrared shows moisture in blue. (this is located by the front door) Moisture meter shows 90% moisture present. This is considered active.

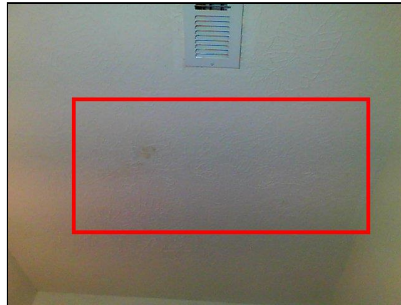
5.0 Item 5(Picture)

(2) In the primary bathroom down stairs, infrared shows in blue where moisture is present. This is located under the secondary bathroom where the drain was leaking.

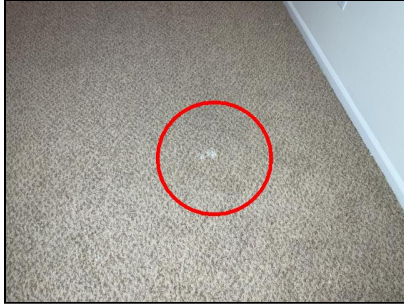
5.2 Item 2(Picture)

(2) Downstairs paint on the carpet.

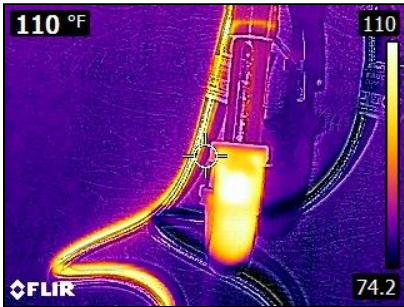
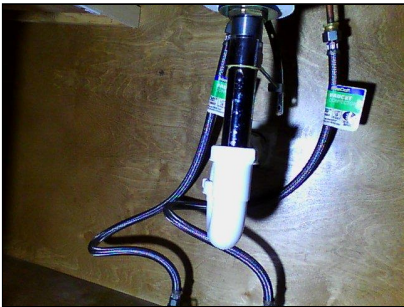
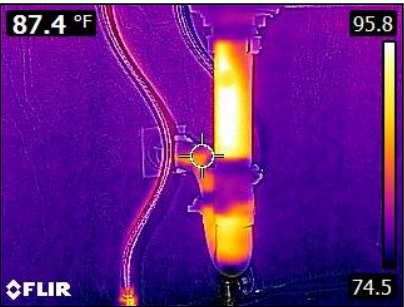
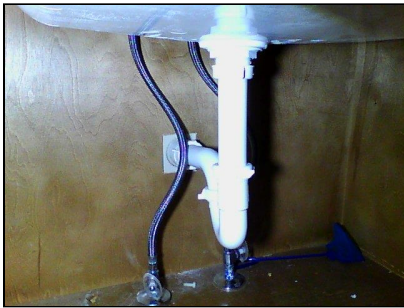
(3) Infrared shows water in yellow. No leaks found during the inspection.(including the laundry room)

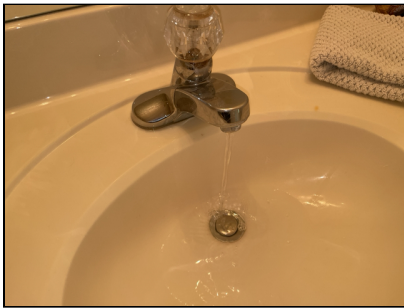
6.2 Item 1(Picture)

Upstairs in the primary bathroom low water pressure on the hot water side of the sink.

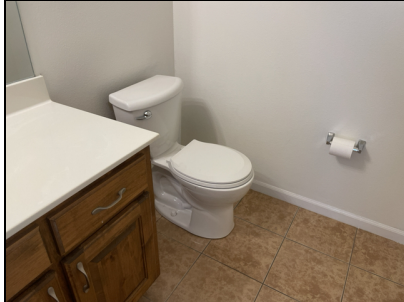
6.4 Item 1(Picture)

(1) The toilet is loose at the floor. Repairs may involve re-setting the toilet on a new wax seal. I recommend a qualified contractor repair or correct as needed.(Primary bathroom downstairs.)

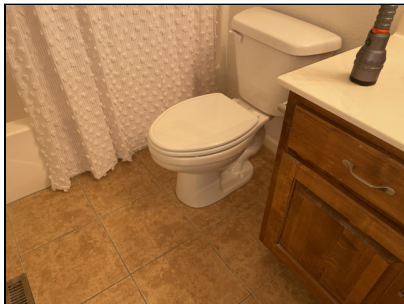
6.4 Item 2(Picture)

(2) The toilet is loose at the floor. Repairs may involve re-setting the toilet on a new wax seal. I recommend a qualified contractor repair or correct as needed.(Upstairs in the primary bathroom.)

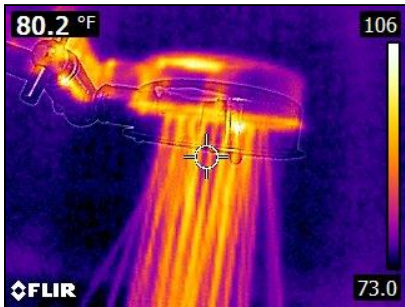
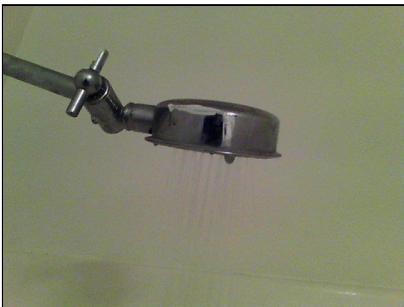
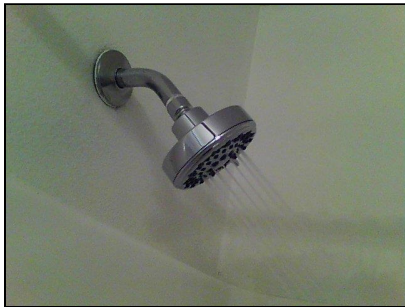
(2) Shower in all bathroom, mixing valve operating satisfactory with a temp of around 90.3 degrees. Temp top left on the photo.

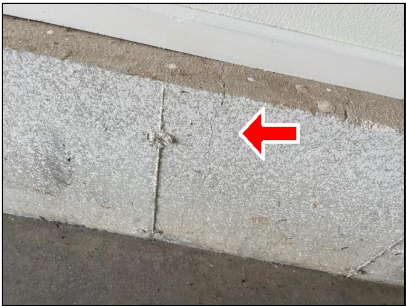
7.0 Item 2(Picture)

(1) A vertical crack in various places. Recommend maintaining a positive slope so water will drain away from the foundation.

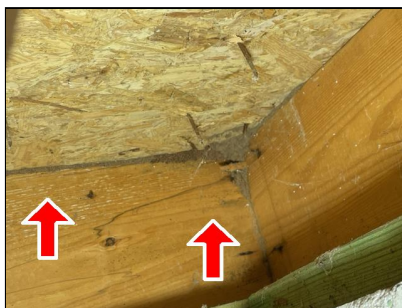
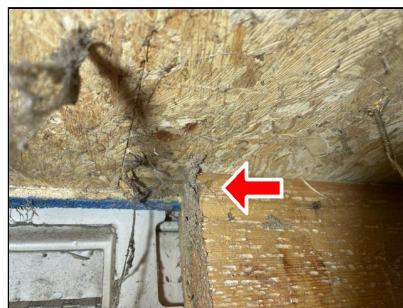
Evidence of Termites observed.

Recommend a licensed pest control operator's evaluation for the scope of treatment/costs if not currently under a warranty.

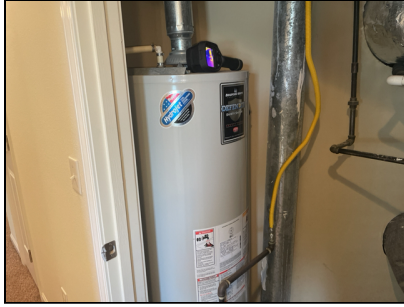
8.3 Item 3(Picture)

(2) The hot water tank is making a popping noise. This is sometimes due to debris in the tank.

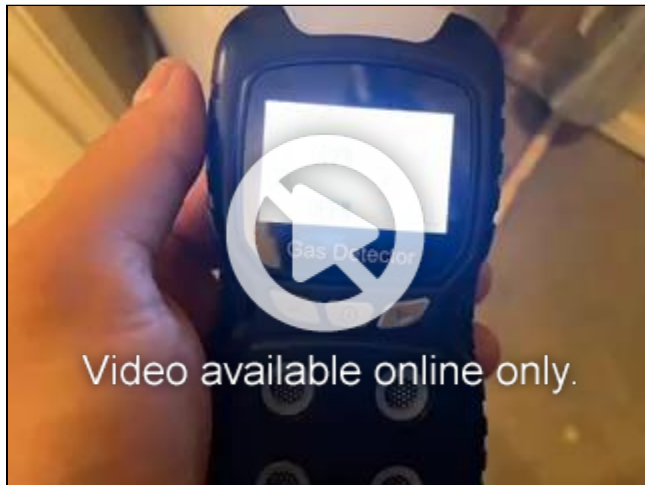
8.6 Item 1(Video)

(1) No leaks detected during the inspection.(furnace/hot water tank)

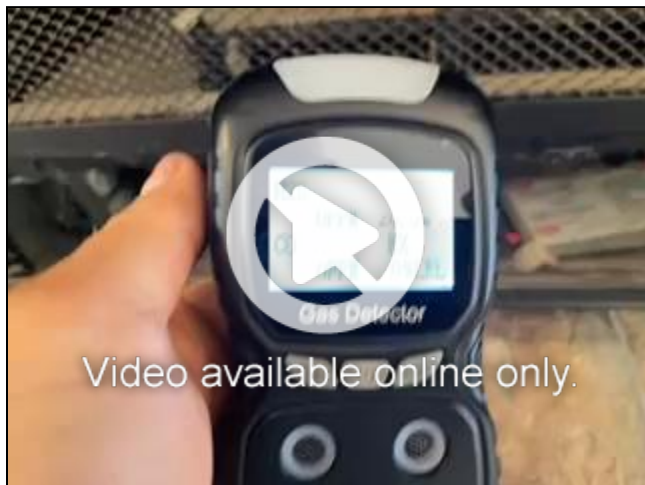
8.6 Item 2(Video)

(2) No leaks were detected during the inspection.(fireplace)

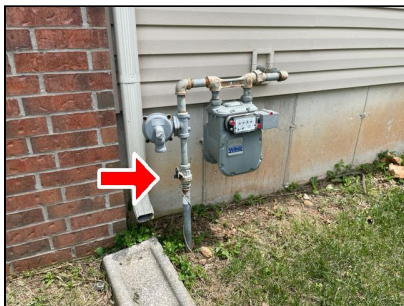
8.7 Item 1(Picture)

The primary fuel shut-off is at the gas meter outside.

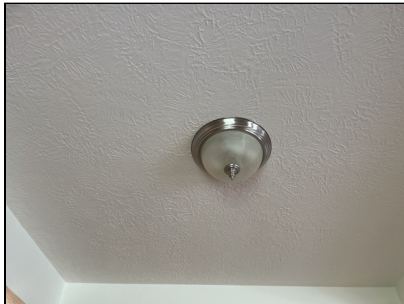
9.4 Item 1(Picture)

The light in the kitchen would not turn on. Possibly the bulb is out.

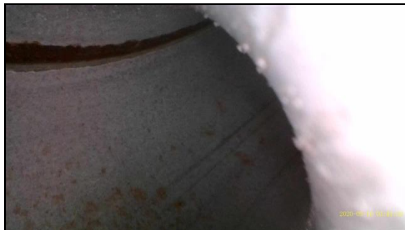
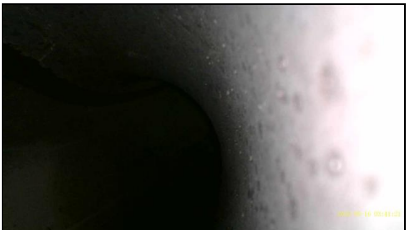
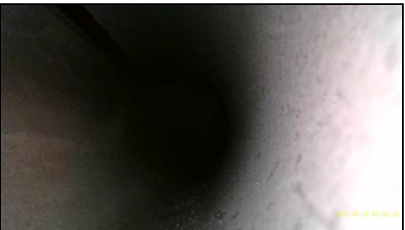
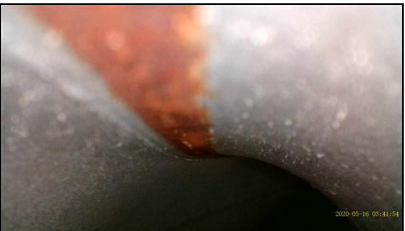
(2) The heat exchanger was satisfactory during the inspection.

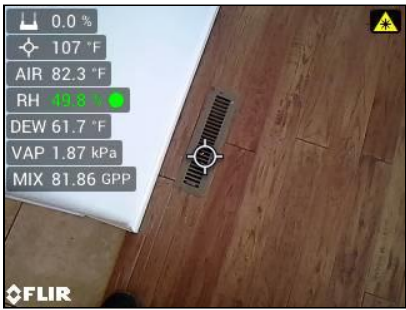
10.1 Item 1(Picture)

Temp reading from the duct was around 107 degrees.Temp top left on the photo. Heating system was satisfactory during the inspection. Recommend the start of the heating season(each year) a HVAC specialist service the system.

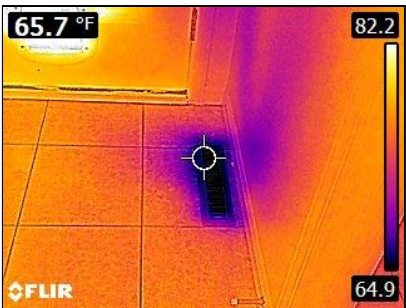
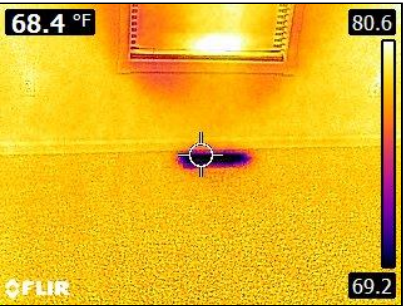
Infrared shows in blue each duct operating satisfactory during the inspection.

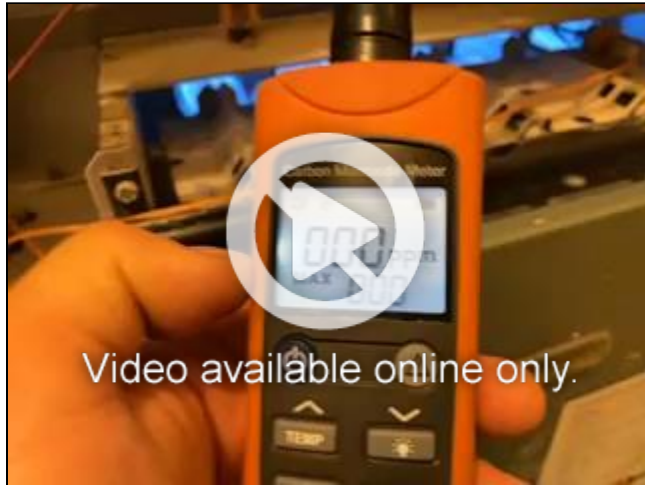
10.5 Item 1(Video)

(1) No carbon monoxide detected during the inspection.

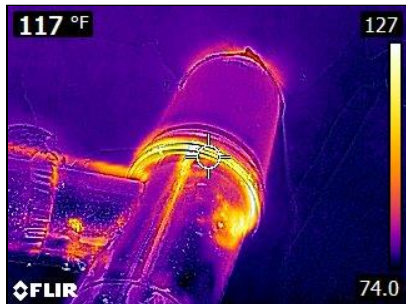
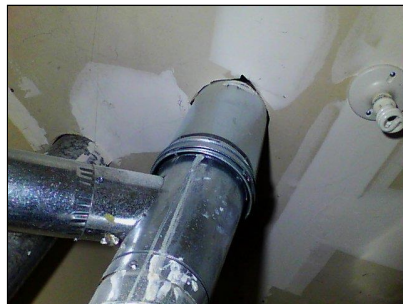
(2) Infrared shows a safe temp exiting the home.

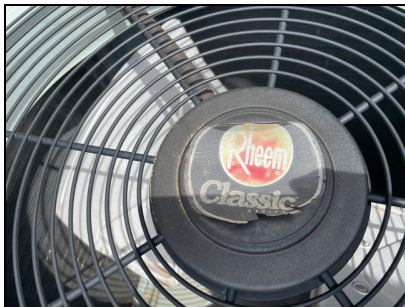
(1) Information.

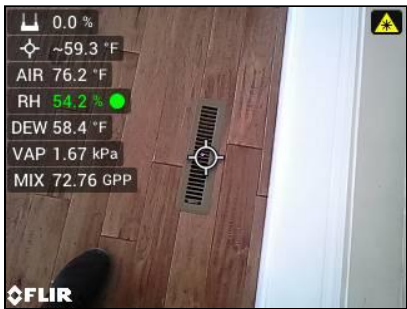
10.9 Item 1(Picture)

The ambient air test was performed by using thermometers on the air handler of Air conditioner to determine if the difference in temperatures of the supply and return air are between 14 degrees and 22 degrees which indicates that the unit is cooling as intended. The supply air temperature on your system read 59.3 degrees, and the return air temperature was 78 degrees. This indicates the range in temperature drop is normal. Recommend the start of the season needing AC(each year) a HVAC specialist service the system.

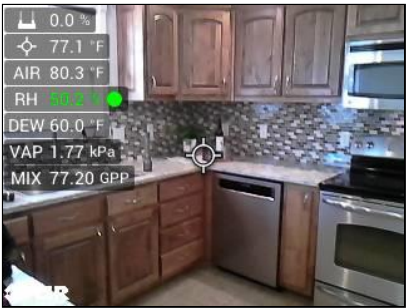
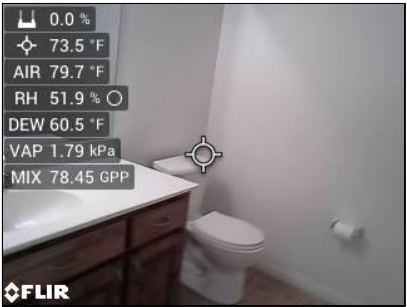
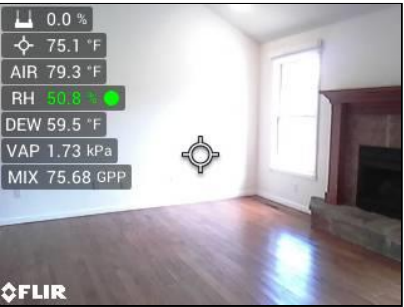
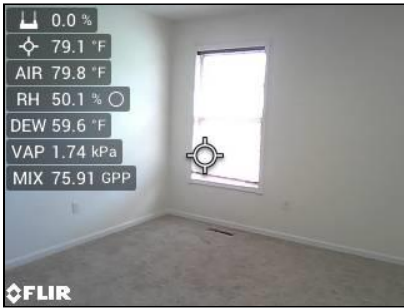
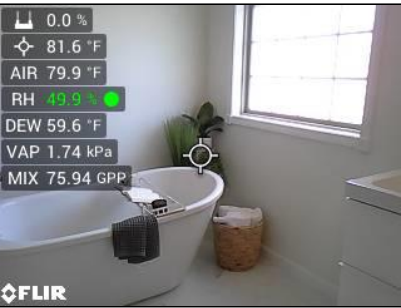
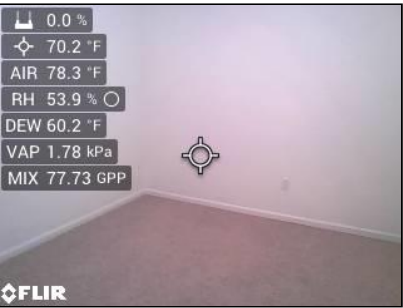
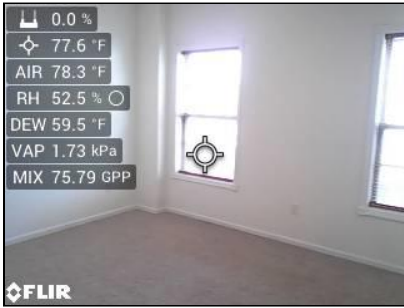
Air temp with RH and DEW in each room. Information left on the photo. This gives an insight on how the system is preforming through out the home.
